4. TITLE (and Subtitle) Moodus Reservoir Dam		5. TYPE OF REPORT & PERIOD COVERED INSPECTION REPORT
NATIONAL PROGRAM FOR INSPECTION OF NON-FEDERAL DAMS		6. PERFORMING ORG. REPORT NUMBER

MOODUS RESERVOIR DAM

CT 00350

PHASE 1 INSPECTION REPORT  
NATIONAL DAM INSPECTION PROGRAM

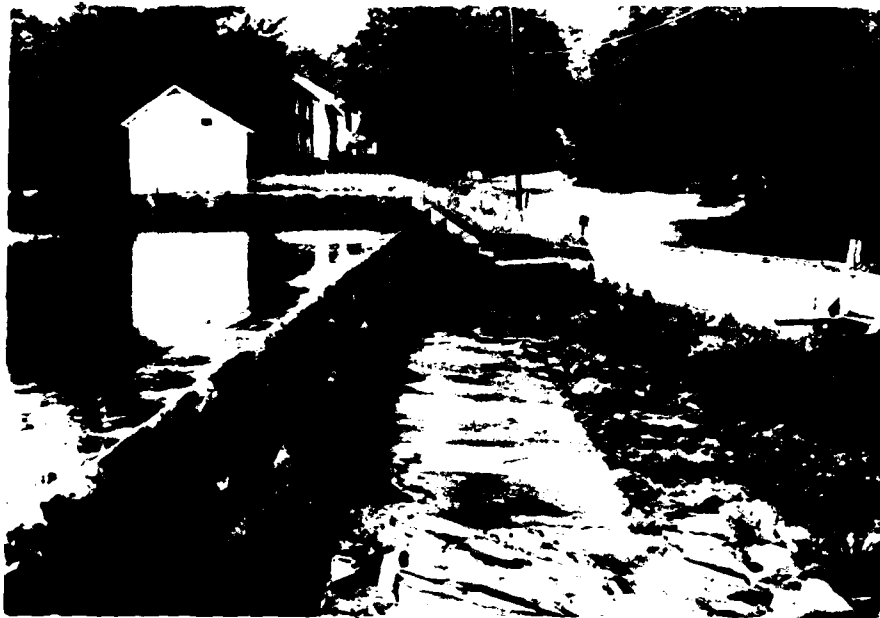
C-2 SPILLWAY, GATEHOUSE AND LEFT ABUTMENT-LOOKING FROM RIGHT ABUTMENT.

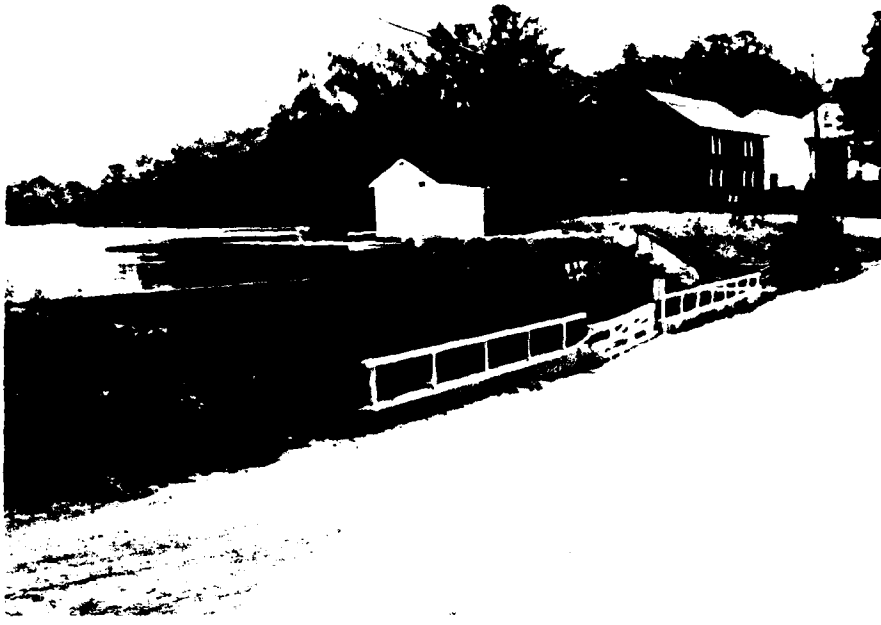
should be analyzed to insure its structural integrity and waterway opening adequacy. It is recommended that the roadway section downstream of the dam should be analyzed for stability against overtopping and erosion. See Photos C-4 through C-9.

way opening in the embankment is rectangular (18 feet long by 8 feet high). Using a test flood of 6898 cfs and the dam failure flow of 7613 cfs, it was found that this bridge opening (144 sq. ft.) is too small to allow passage of a significant portion of the test flood or dam failure flow and therefore the roadway embankment will be overtopped. A further detailed analysis of this problem is required.

C-4 ROADWAY AND BRIDGE IMMEDIATELY DOWNSTREAM FROM DAM.

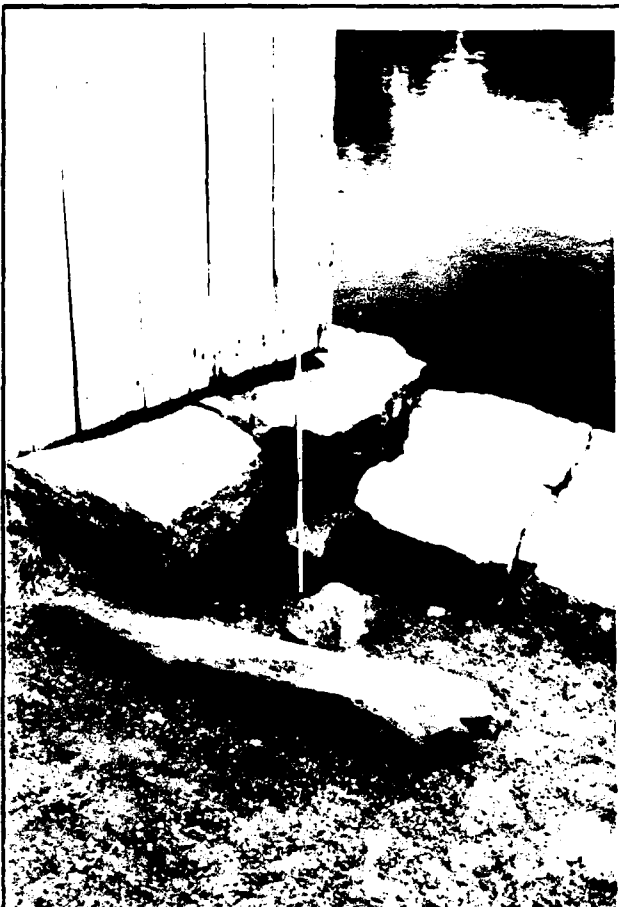
C-10 SURFACE EROSION AT  
GATEHOUSE.

6. Institute immediately an analysis for the short term repairs and/or rehabilitation of the dam embankment in those areas where erosion has occurred including erosion near the gatehouse.
